**INDEPENDENT
ENVIRONMENTAL AUDIT
REPORT**

27-29 and 37 Bancroft Avenue, Roseville

The Anglican Schools Corporation
17 May 2024

AU122160 R4

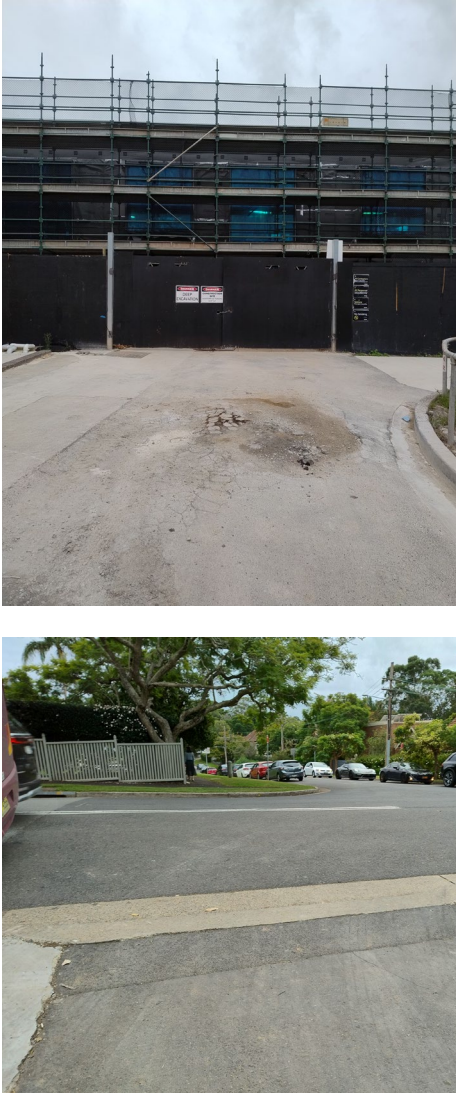
<p>Photo Number: G87, B186</p>	<p>Date: 4/4/2024</p>

<p>The top photograph shows a multi-story building under construction, completely encased in a dense network of metal scaffolding. The building's facade is dark, and the sky above is overcast. In the foreground, there is a wide, light-colored paved area, possibly a road or parking lot, with some minor stains and a curb on the right side.</p> <p>The bottom photograph shows a street scene with a paved road in the foreground. In the background, there are several cars parked along the side of the road, a white fence, and lush green trees. A house with a red roof is visible through the trees in the distance.</p>
<p>Description: Public road was observed to be clean.</p>

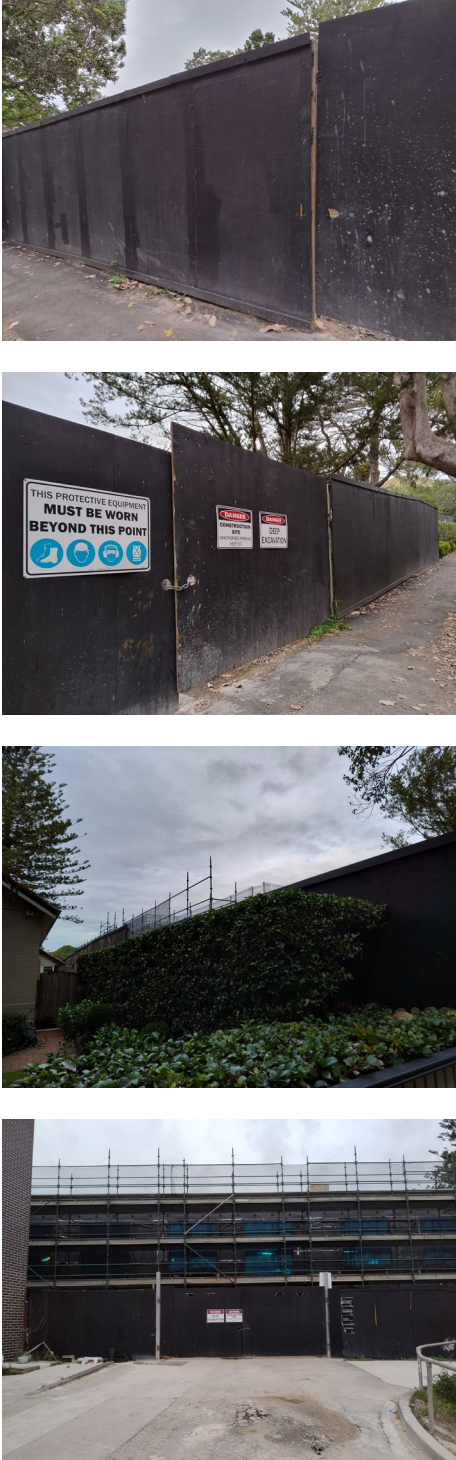
<p>Photo Number: G146, G191</p>	<p>Date: 4/4/2024</p>

<p>The photographs show: 1) A close-up of a black hoarding panel. 2) A hoarding wall with safety signs, including one that reads 'THIS PROTECTIVE EQUIPMENT MUST BE WORN BEYOND THIS POINT' and another for 'CONSTRUCTION SITE DEEP EXCAVATION'. 3) A view of a building partially obscured by a large green hedge. 4) A view of a building under construction with extensive scaffolding.</p>
<p>Description: Hoarding observed along Bancroft Avenue and along eastern boundary.</p>

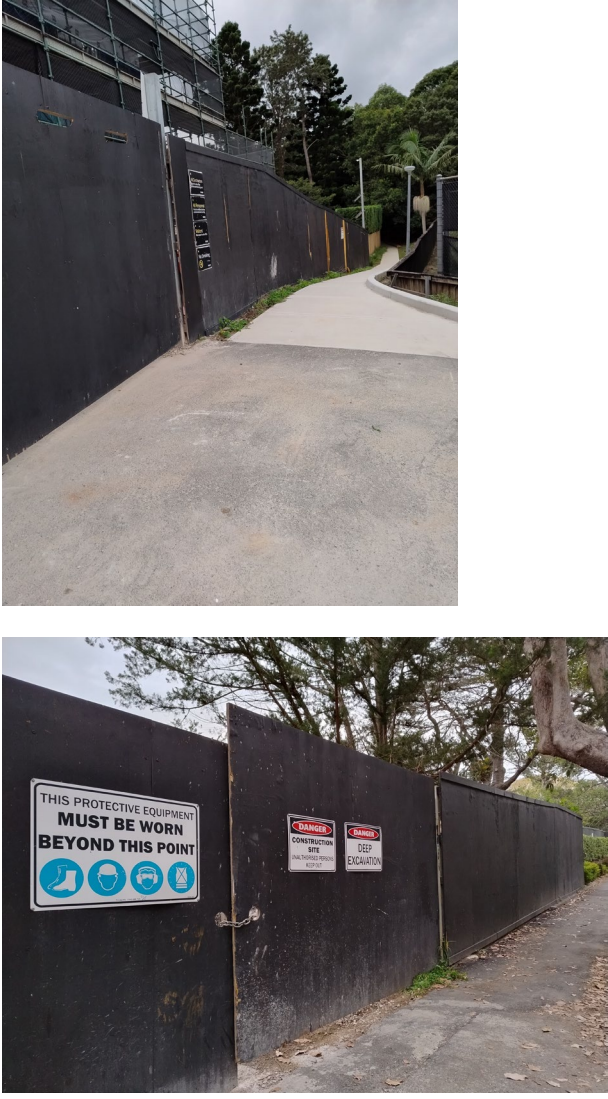
<p>Photo Number: G154, G191, G197</p>	<p>Date: 4/4/2024</p>

<p>Description: Pedestrian pathways were observed to be unobstructed.</p>

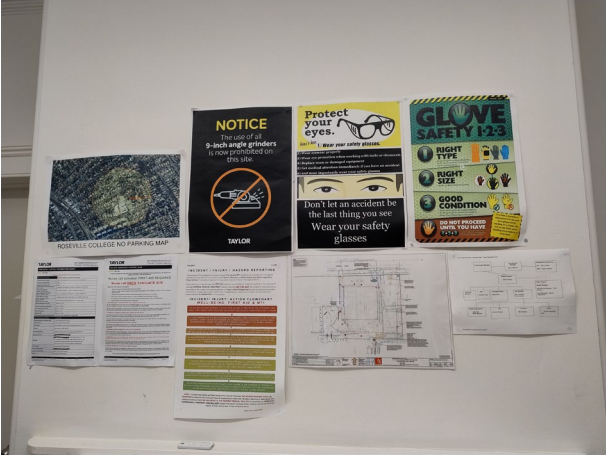
<p>Photo Number: G181</p>	<p>Date: 4/4/2024</p>

<p>Description: Emergency posters were observed in the site office.</p>
